Item Name: Fwd Crosstube - Mid Height 206L / L1 / L3 / L4, Blue

Work Order ID 138476

DART AEROSPACE LTD		Work Order:	138476
Description: Crosstube Mid Fwd (206L)		Part Number:	D206-667-107
Inspection Dwg: D206-667-147 Rev: A		Page 1 of 1

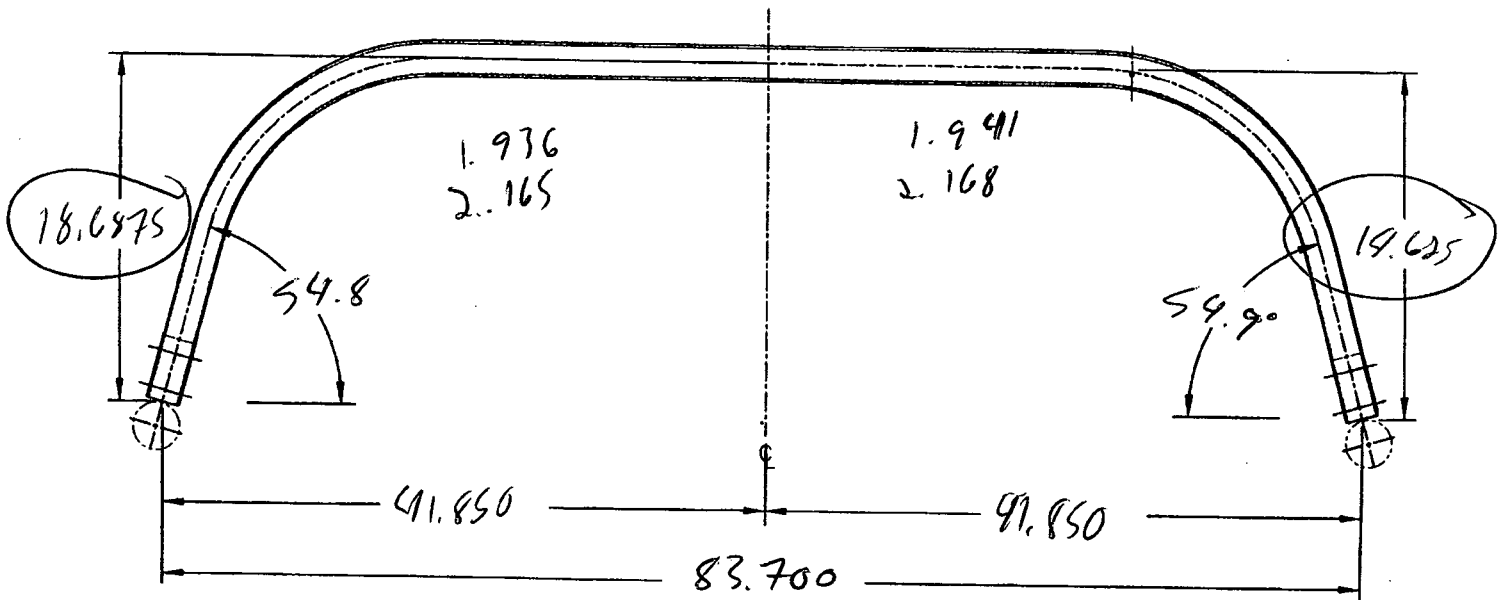
Required Dimension	Min	Max
Height	18.34	18.60
1/2 Span	41.79	42.05
Angle	54°	56°
Total Span	83.59	84.09
Bending Passes	10	--
Crushing	--	6%

Side A	Side B
Bending Passes	16	16
Crushing	5.6%	5.5%
Comments
